Perfect Choice Home Inspection Services Inc.
106 Lyric Way
Warrington, PA 18976
(215)869-2094
(215)869-2094
perfectchoiceinspections@yahoo.com

BUILDING ANALYSIS REPORT

Date of Inspection: 11/24/2013

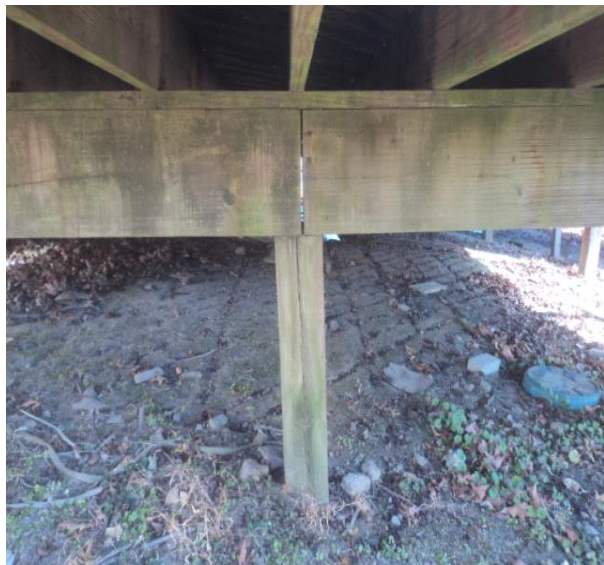
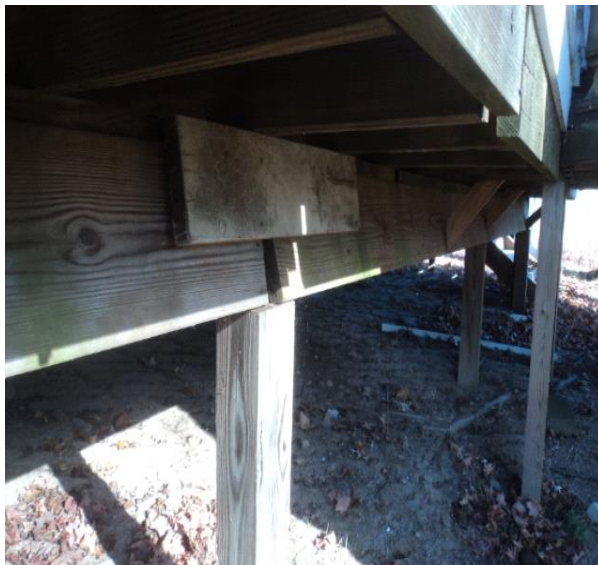
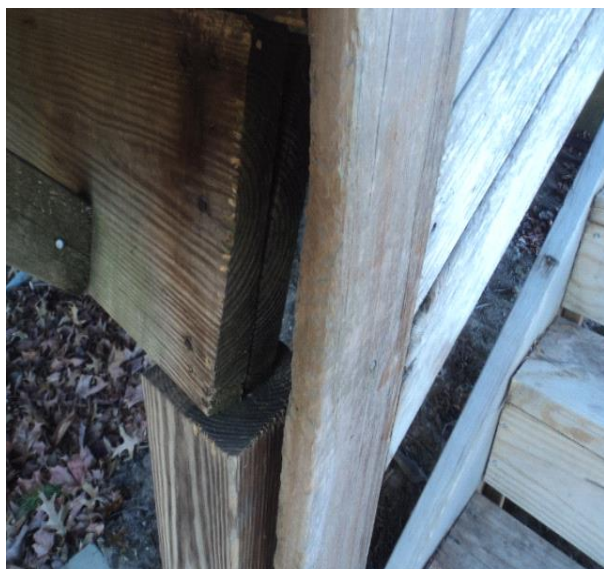
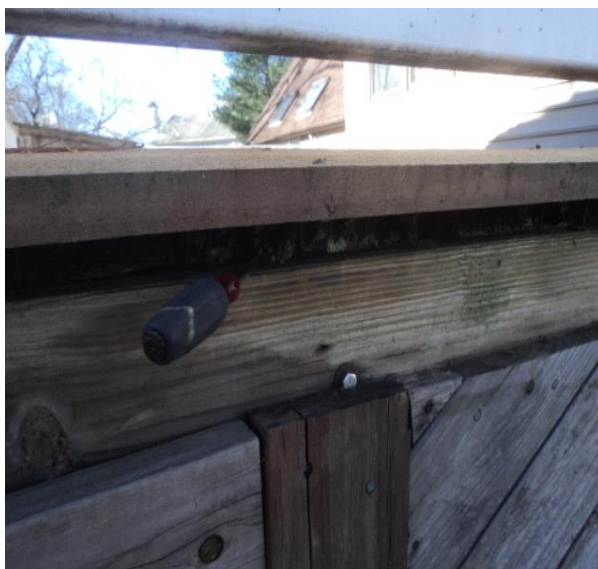
Remarks	<i>Foundation wall-Limited access and visibility due to finished basement. Deck structure-Rear deck is not structurally sound. Deck support posts are not level. Girder is twisted. Building contractor should examine deck structure for adequacy repair as needed and issue certification.</i>		
BASEMENT	<input type="checkbox"/> Full <input checked="" type="checkbox"/> Partial <input type="checkbox"/> None <input type="checkbox"/> Slab on grade Walls: <input type="checkbox"/> Open <input type="checkbox"/> Closed Ceiling: <input type="checkbox"/> Open <input type="checkbox"/> Closed <input type="checkbox"/> Limited visibility due to extensive basement storage		
FLOOR	<input checked="" type="checkbox"/> Concrete <input type="checkbox"/> Dirt <input type="checkbox"/> Resilient tile <input type="checkbox"/> Sheet goods <input type="checkbox"/> Carpeting	<input checked="" type="checkbox"/> Satisfactory <input type="checkbox"/> N/A

DSC06478.JPG
Structural damage to deck stucture.

DSC06479.JPG
Structural damage to deck stucture.

DSC06480.JPG
Structural damage to deck stucture.

DSC06481.JPG
Structural damage to deck stucture.

Contractor should examine rear deck structure for adequacy and repair as needed (support posts are not level, girder twisted). Call contractor for estimate.

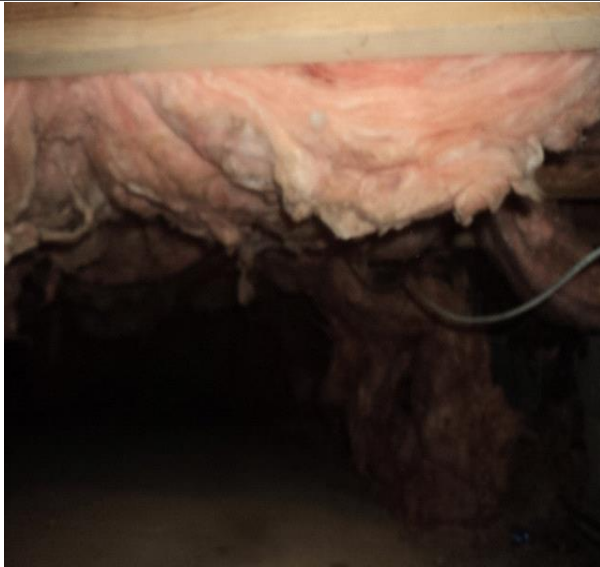
DSC06486.JPG
Re-install Insullation in the crawl space.

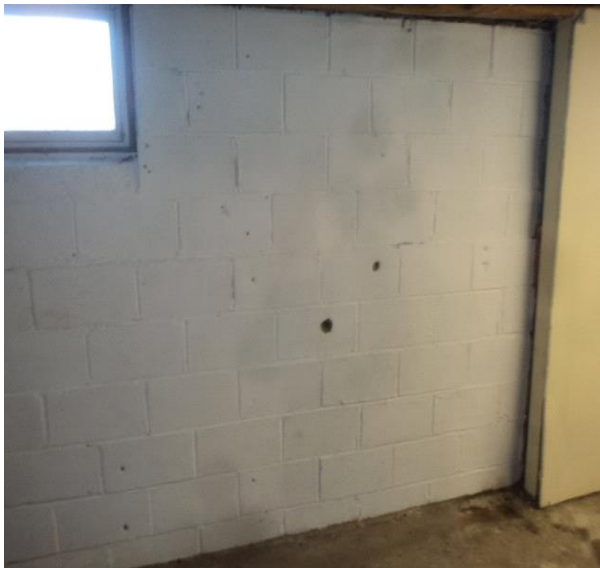
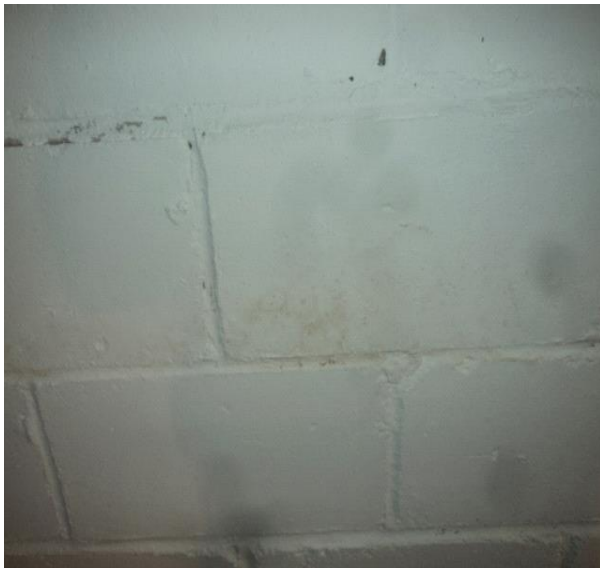
DSC06488.JPG
Recently painted foundation wall.

DSC06492.JPG
Recently painted foundation wall.

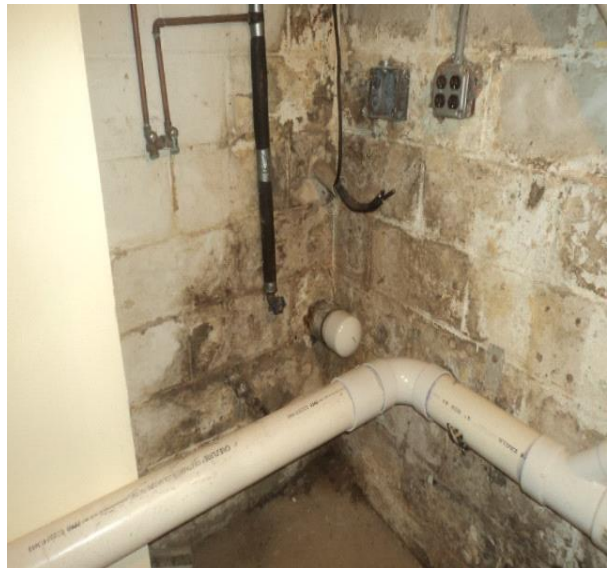
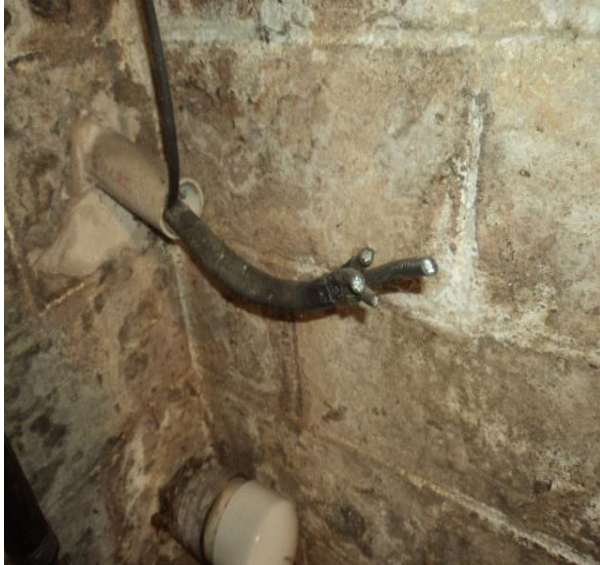
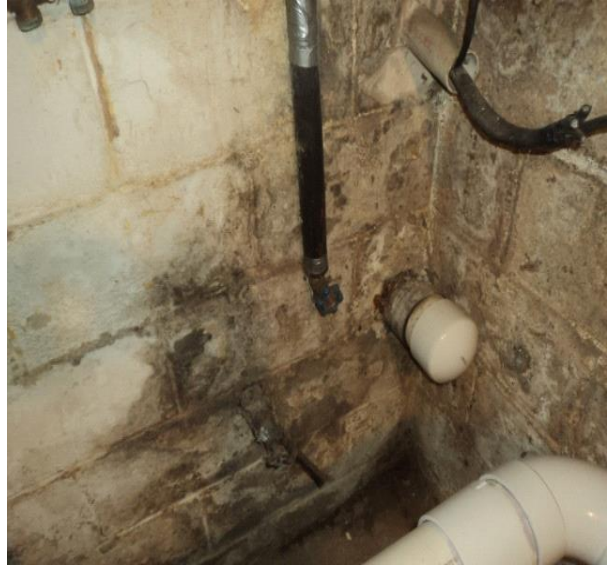
DSC06489.JPG
Signs of exterior water penetration into the basement.

DSC06490.JPG
Signs of exterior water penetration into the basement.

DSC06491.JPG
Signs of exterior water penetration into the basement.

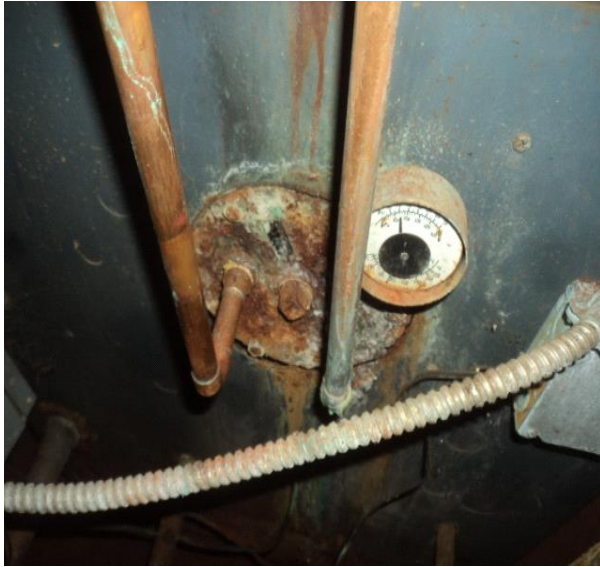
DSC06499.JPG
Leaky domestic hot water heat exchanger.
Damaged pressure/temperature gauge.

HVAC mechanic should examine forced hot water boiler, repair as needed and issue boiler certification (gas smell around forced hot water boiler, damaged pressure/temperature gauge, safety control hanging on wires, leaky domestic hot water heat exchanger). No heat in rear left bedroom.

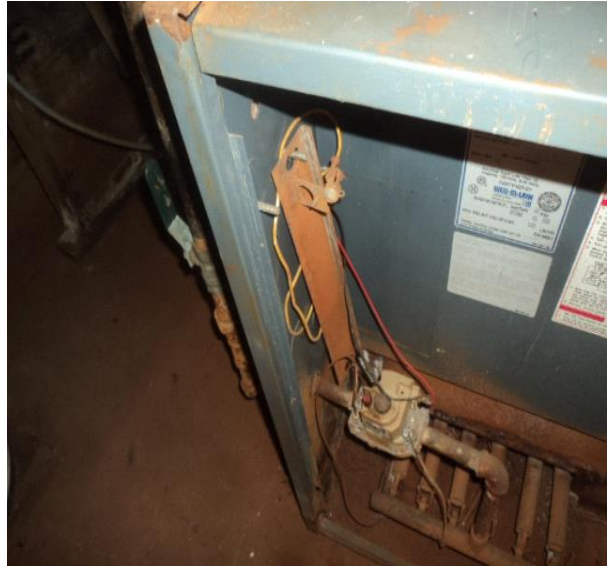
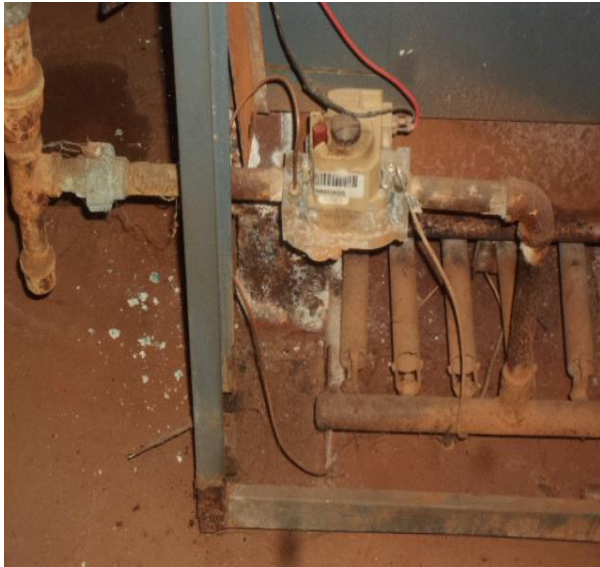
DSC06500.JPG
Rusty heat exchanger.

DSC06501.JPG
Rusty heat exchanger.

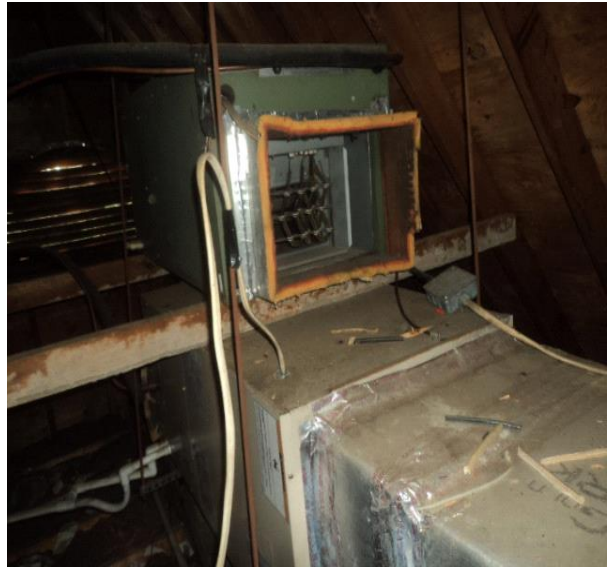
DSC06519.JPG
Abandoned old A/C interior unit in the attic.

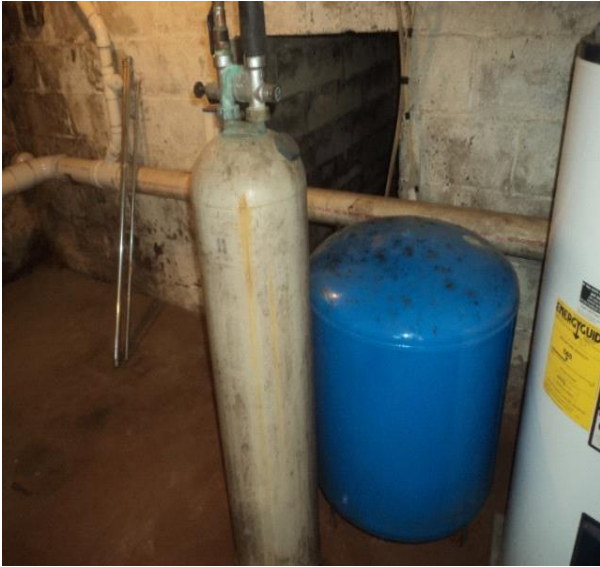
DSC06493.JPG
Abandoned private water tank, pump.

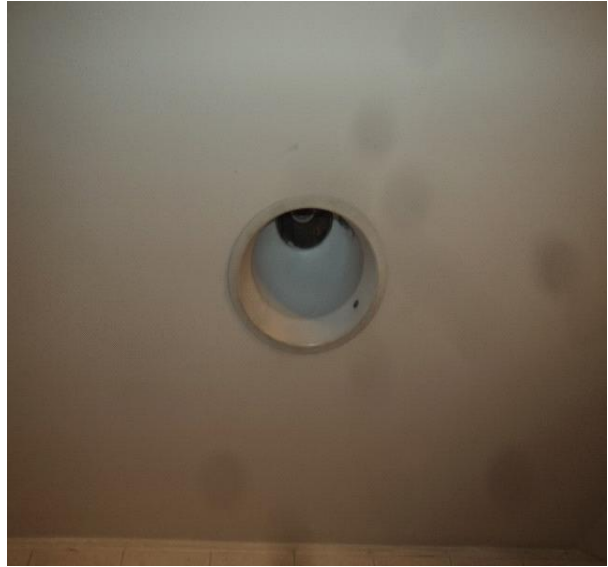
DSC06513.JPG
Light fixture in tub area (electrical hazard).

Replace existing ceiling light fixture with waterproofed light fixture in tub area (electrical hazard) (\$170.00).

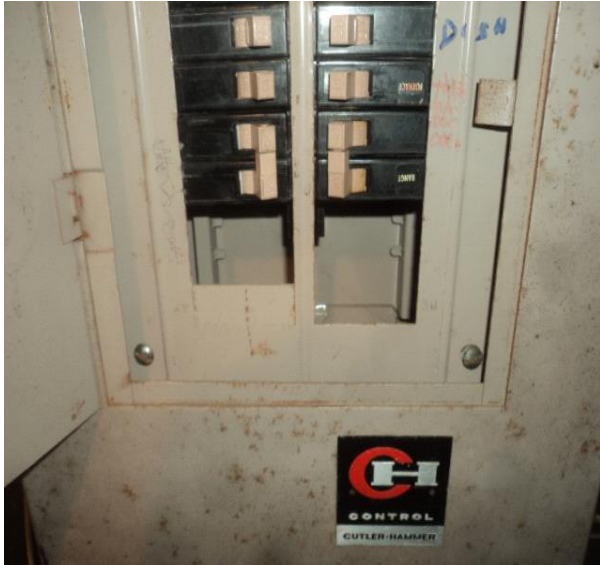
DSC06494.JPG
Missing knockout plugs.

Licensed electrician should examine main panel box and subpanel, repair as needed and issue certification (main panel box not properly secured to the basement wall. Double taps in panel box. Knockout plugs missing on front panel. Missing ground wire to water supply pipe.

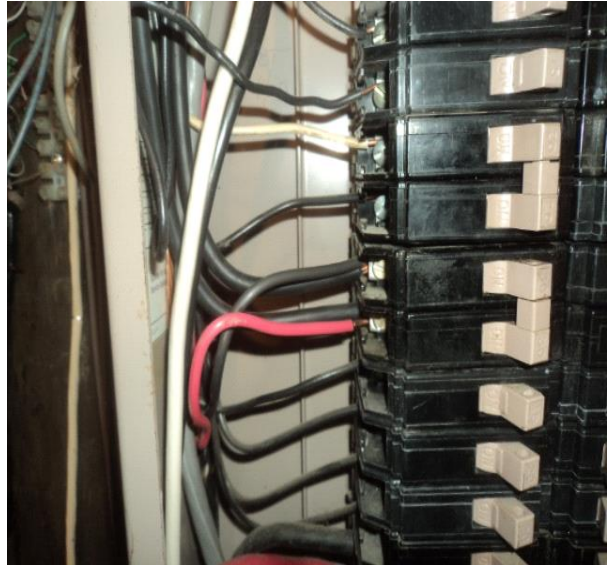
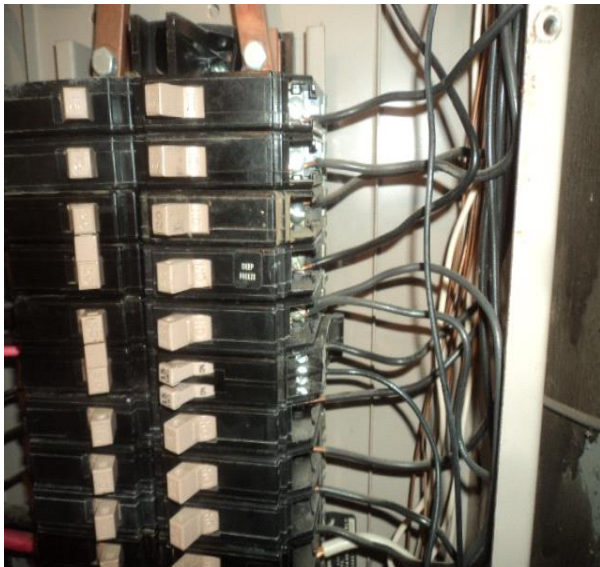
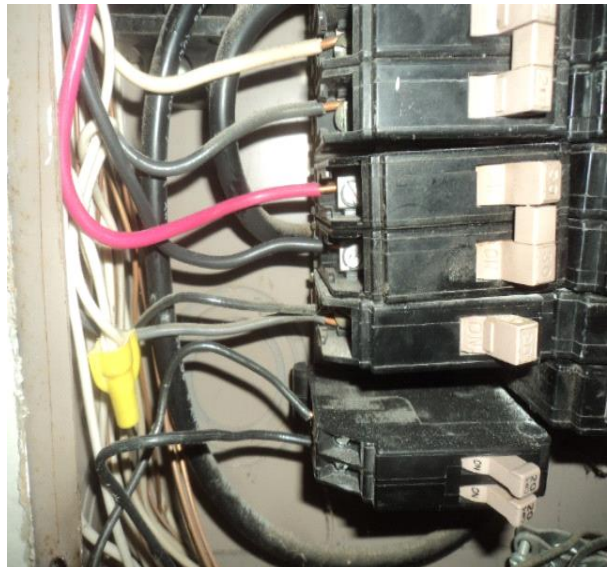
DSC06497.JPG
Double tap to circuit breaker in main panel box.

DSC06498.JPG
Double tap to circuit breaker in main panel box.

DSC06508.JPG
Double tap to circuit breaker in main panel box.

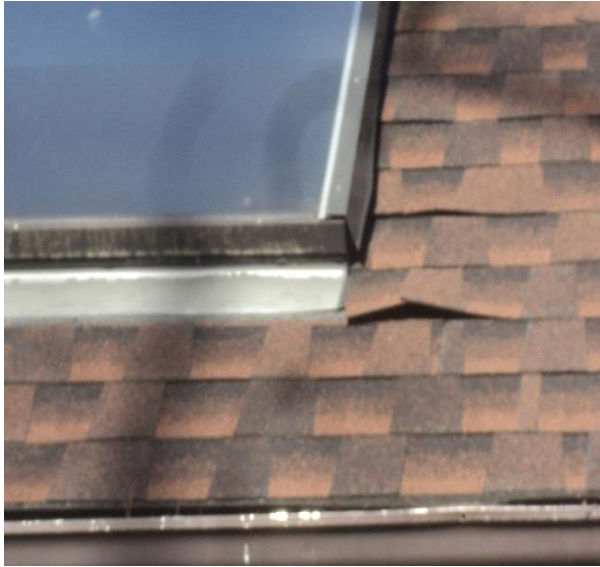
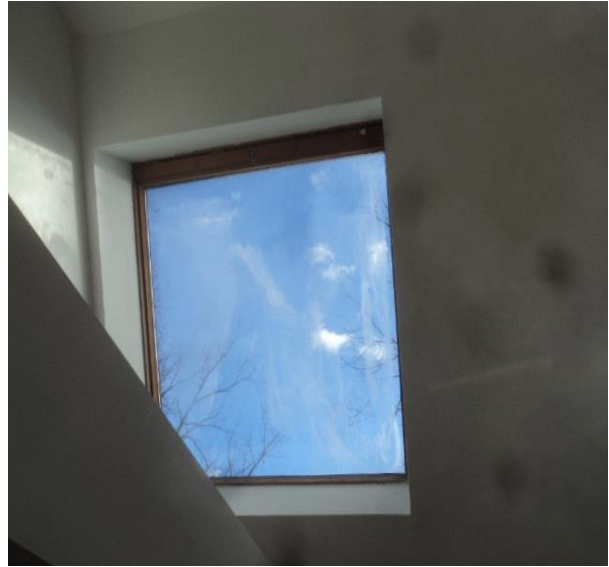
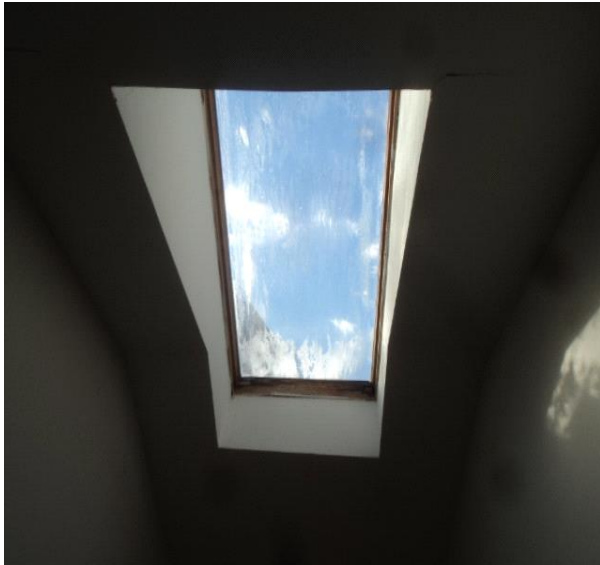
Remarks	<p><i>Sunroom windows-Sunroom windows would not open or close properly. Repairs or replacement needed. Broken window seal was noted in:1) sunroom skylight, 2)family room skylight, 3)skylight above stairs to the 2nd floor. Replacements needed. Window in the rear left bedroom would not open or close properly. (see page9)</i></p>	
ACCESS	How Inspected: <i>walked through</i> <input type="checkbox"/> Not inspected <input type="checkbox"/> Stairs <input checked="" type="checkbox"/> Pulldown <input type="checkbox"/> Scuttlehole <input type="checkbox"/> No access	<input checked="" type="checkbox"/> Satisfactory <input type="checkbox"/> N/A
MOISTURE STAINS	<input type="checkbox"/> Some signs <input type="checkbox"/> Extensive <input checked="" type="checkbox"/> None observed <input type="checkbox"/> Condensation	
STORAGE	<input type="checkbox"/> Heavy <input type="checkbox"/> Light <input type="checkbox"/> Floored <input checked="" type="checkbox"/> Not floored <input checked="" type="checkbox"/> No storage

DSC06476.JPG
Broken window seal.

DSC06507.JPG
Broken window seal.

DSC06514.JPG
Broken window seal.

Replace skylights (broken windows seal):

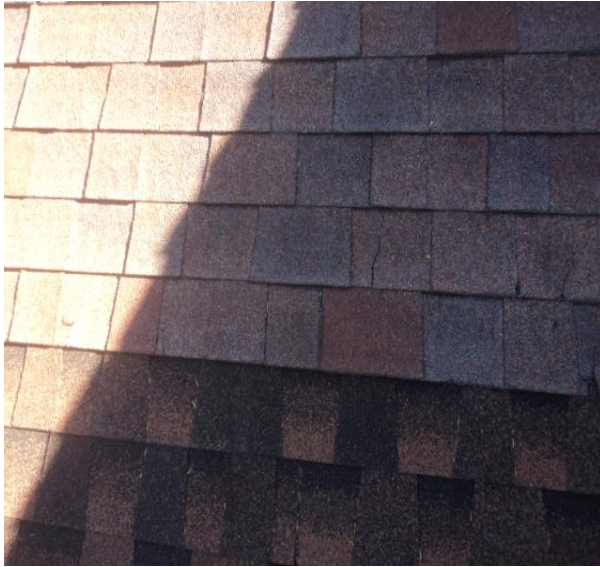
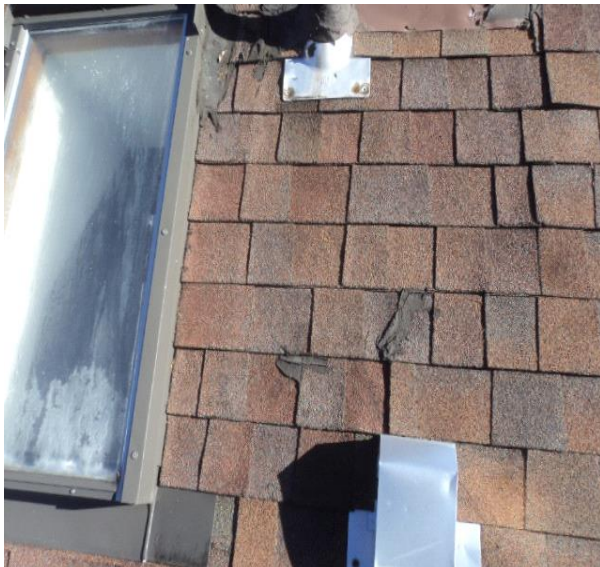
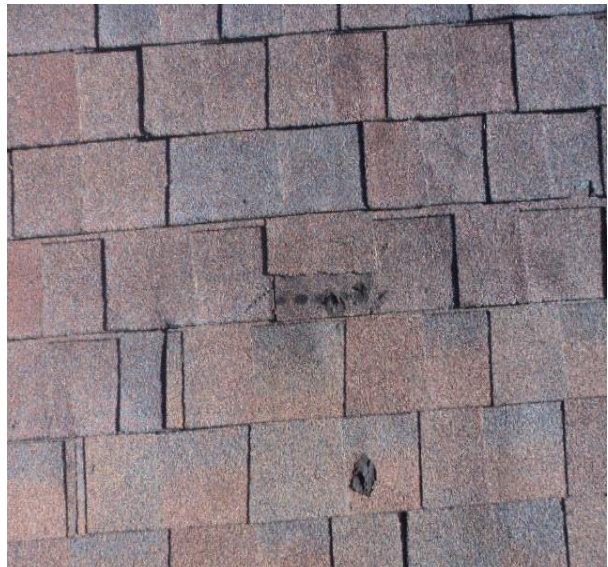
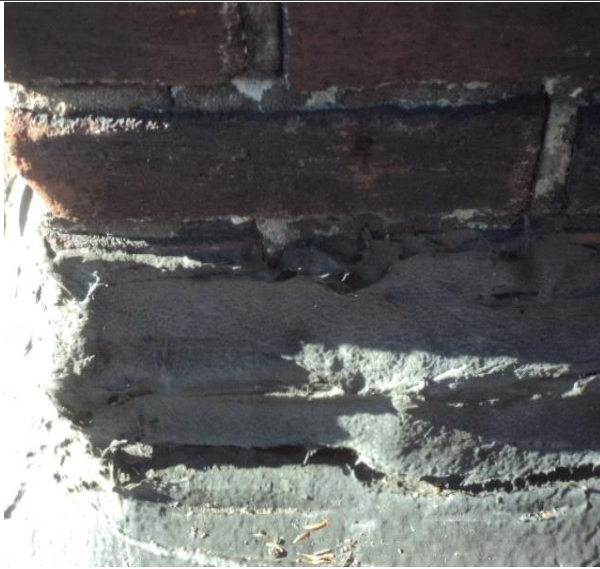
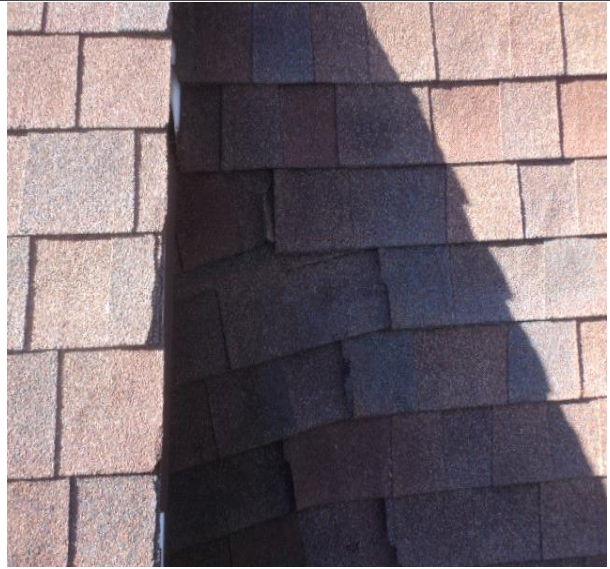
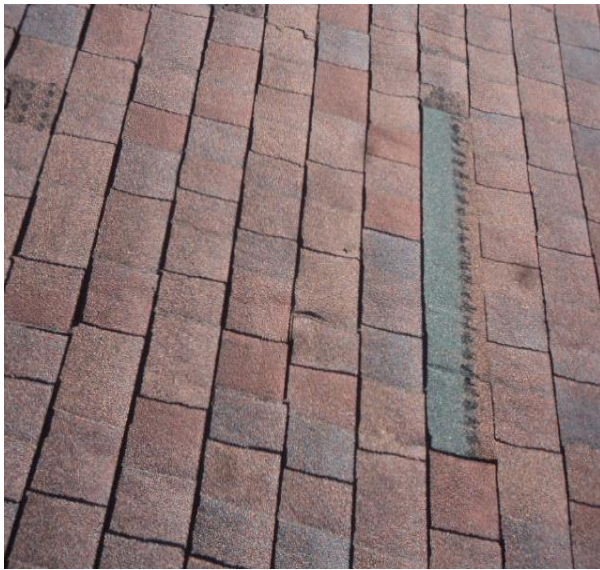
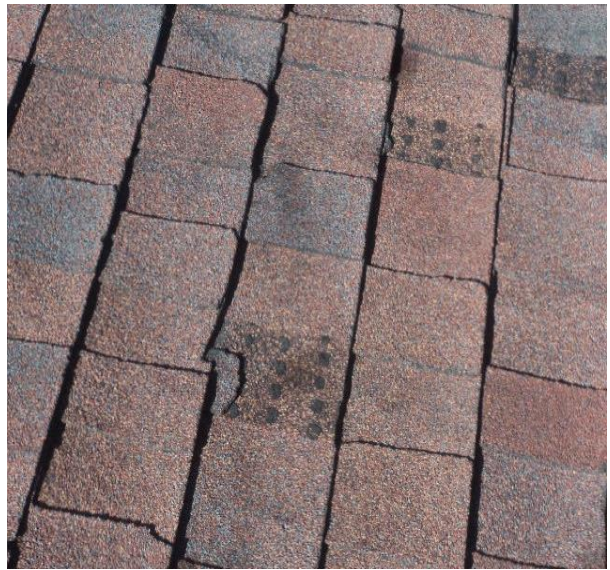
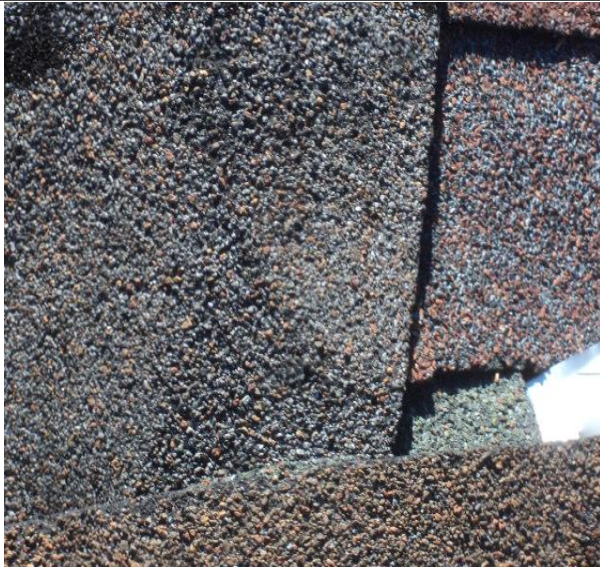
Remarks	<p><i>Original house roof-Exterior roof covering past its estimated life expectancy (missing, deteriorated asphalt shingles, roof leak noted on rear left bedroom ceiling). Recommend to replace original house roof covering.</i></p> <p><i>Flashing-We suggest you have the flashing replaced when new roof covering is installed.</i></p> <p><i>Gutters full of debris, water overflowing gutters (clean gutters from debris). (see page9)</i></p>			
EXTERIOR DOORS	<input checked="" type="checkbox"/> Satisfactory			
WINDOWS AND SKYLIGHTS	<input type="checkbox"/> Satisfactory			
EXTERIOR WALL COVERING	Location <i>Front</i> <i>Rear</i> <i>Sides</i>	Materials <i>Stucco</i> <i>Vinyl siding</i> <i>Vinyl siding</i>	<input checked="" type="checkbox"/> Satisfactory <input checked="" type="checkbox"/> Satisfactory <input checked="" type="checkbox"/> Satisfactory <input type="checkbox"/> Satisfactory	
EXTERIOR TRIM	<input type="checkbox"/> Eaves <input checked="" type="checkbox"/> Fascia <input checked="" type="checkbox"/> Soffits <input type="checkbox"/> Rake <input type="checkbox"/> Signs of deterioration <input type="checkbox"/> Extensive <input type="checkbox"/> None observed			<input type="checkbox"/> Satisfactory

DSC06457.JPG
Damaged roof shingles.

DSC06459.JPG
Damaged roof shingles.

DSC06461.JPG
Damaged roof shingles.

DSC06462.JPG
Damaged roof shingles.

DSC06463.JPG
Damaged roof shingles.

DSC06464.JPG
Damaged roof shingles.

DSC06465.JPG
Damaged roof shingles.

DSC06466.JPG
Damaged roof shingles.

Replace original house exterior roof covering (missing, deteriorated asphalt shingles, roof leak noted on rear left bedroom ceiling). We suggest you have the flashing replaced when new roof covering is installed.

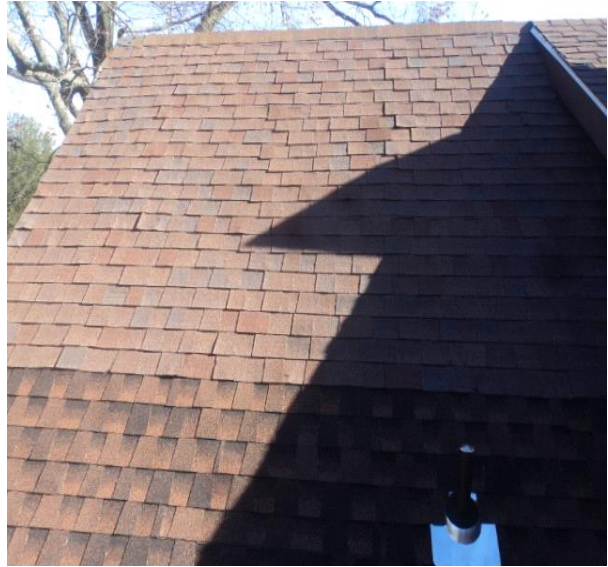
DSC06458.JPG
New and old roof covering.

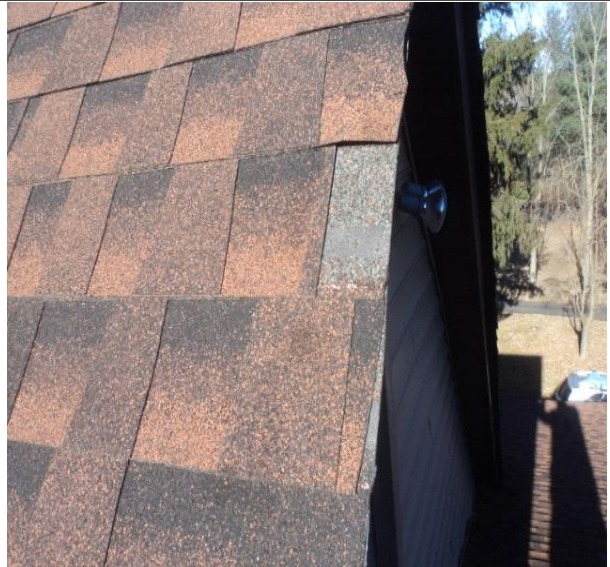
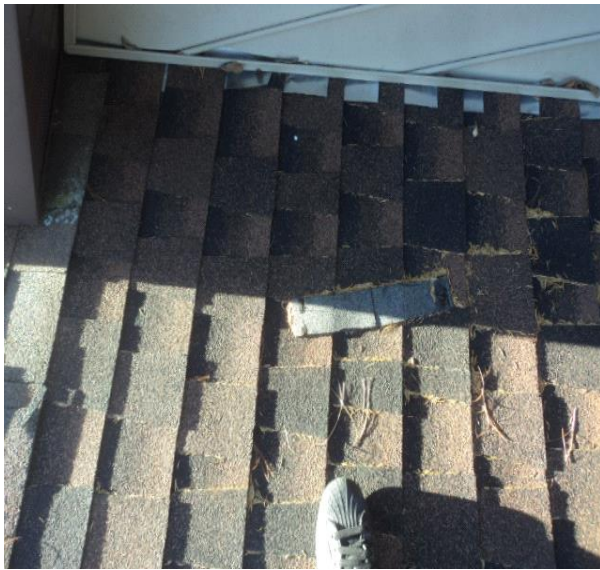
DSC06467.JPG
Missing shingles.

DSC06468.JPG
Missing shingles.

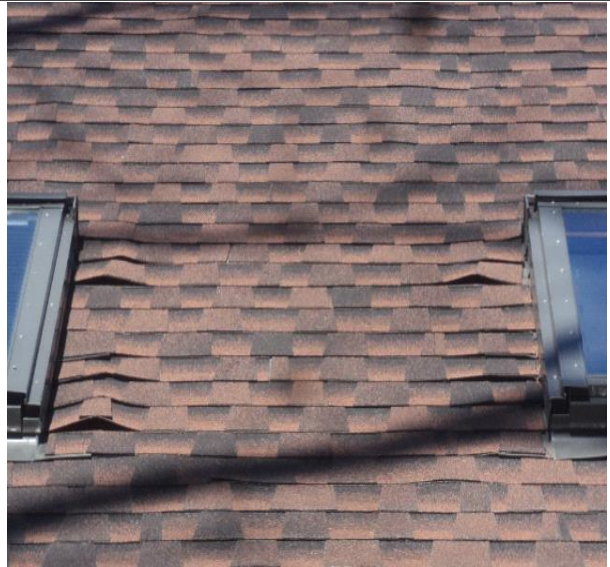
DSC06475.JPG
Lifted shingles.
